Rincon Creek Watershed Plan

Final Rincon Creek Watershed Plan

May 2007

Tetra Tech, Inc.
4213 State Street, Suite 100
Santa Barbara, California 93110

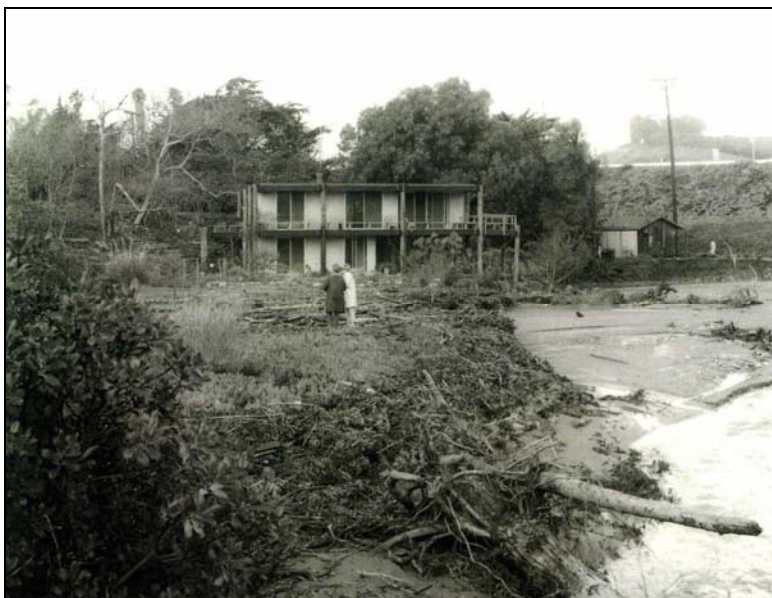
Graphic 4-2: Rincon Point After Flooding that Occurred in 1969

In 1969, large flooding occurred within Rincon Creek. Damage to properties at Rincon Point occurred, as shown in Graphic 4-2.

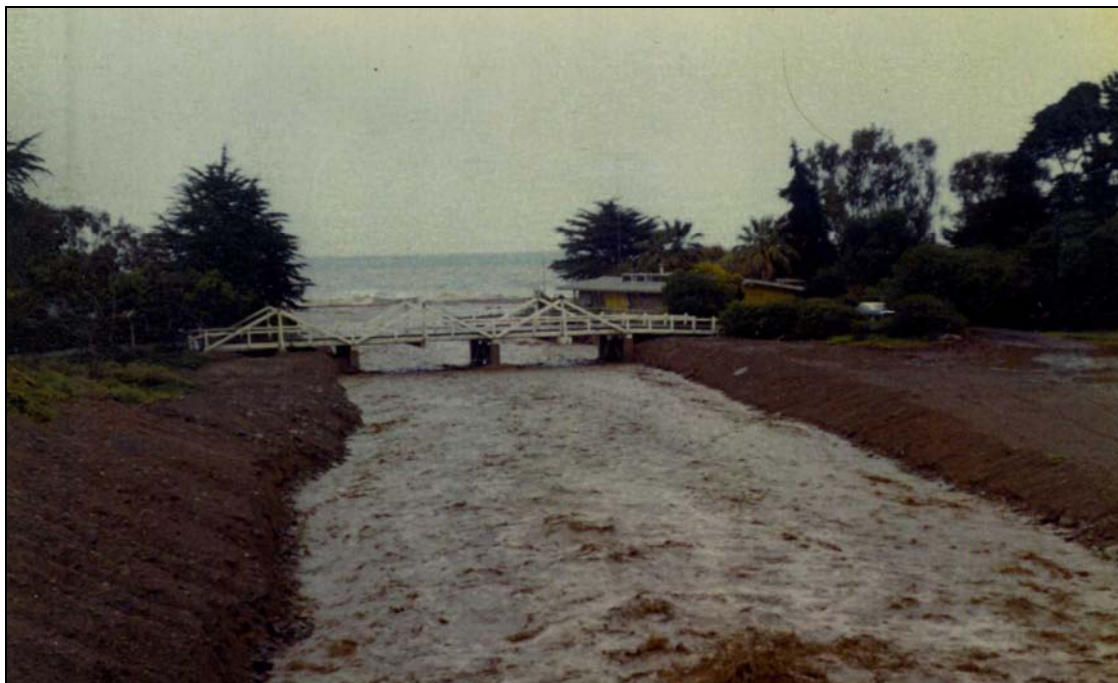
Graphic 4-3: Fill at Rincon Point, after January 1969

Following the 1969 flood, the U.S. Army Corps of Engineers installed unvegetated fill at Rincon Point, as shown in Graphic 4-3.

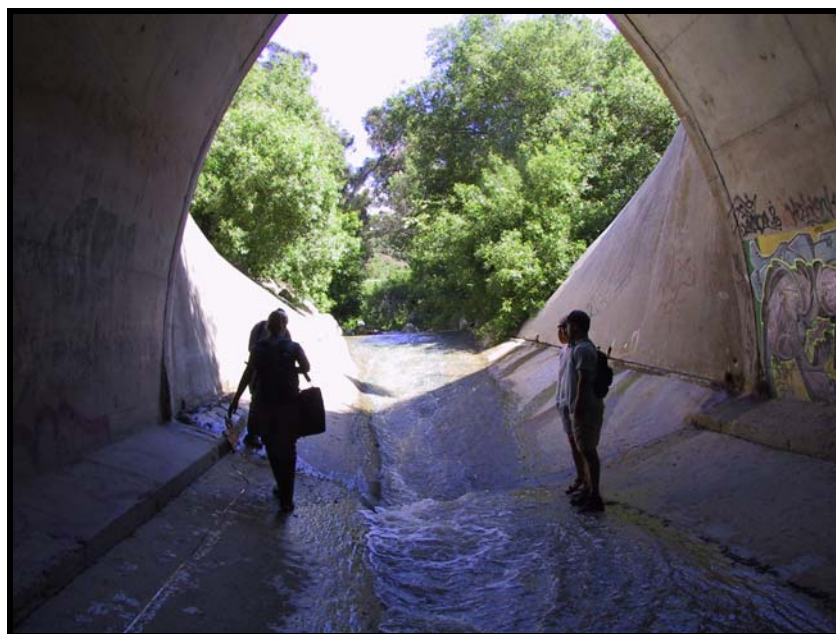
Graphic 7-8: Upstream Apron of the Highway 101 Culvert

**Distance to next upstream barrier indicates the amount of habitat that would be made available if the barrier were removed. For example, remediation of the Highway 101 culvert would provide steelhead access to 4,050 meters of upstream habitat within Rincon Creek, at which point R_2 occurs.

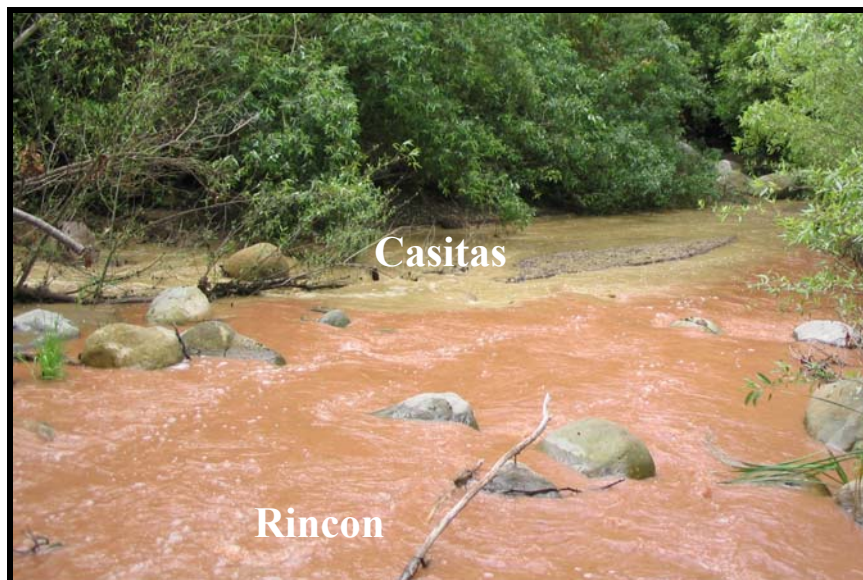
Graphic 7-14: Rincon and Casitas Creeks on Monday, May 22, 2006

On Monday, May 22, 2006 the field survey of Rincon Creek began. Over the weekend, an unexpected rainstorm had occurred, and on Monday slight rain was still occurring. This allowed the field crew the opportunity to visit the confluence of Rincon and Casitas Creeks. Graphic 7-14 shows the state of the Creeks on Monday, May 22, 2006.

Note: Downstream view

Turbidity values were also measured in May 2006. A very distinct pattern of turbidity values is evident for the watershed, as shown in Figure 7-14. Within Rincon Creek from the Highway 101 culvert upstream to the confluence with Casitas Creek, the average turbidity ranged between 100 and 200 NTUs. Within Rincon Creek upstream of the confluence with Casitas Creek, the average turbidity ranged between 0 and 10 NTUs. Average turbidity values within Casitas Creek ranged between 201 and 350 NTUs. This data indicates that Casitas Creek has the most turbid water and is increasing the turbidity of downstream waters.

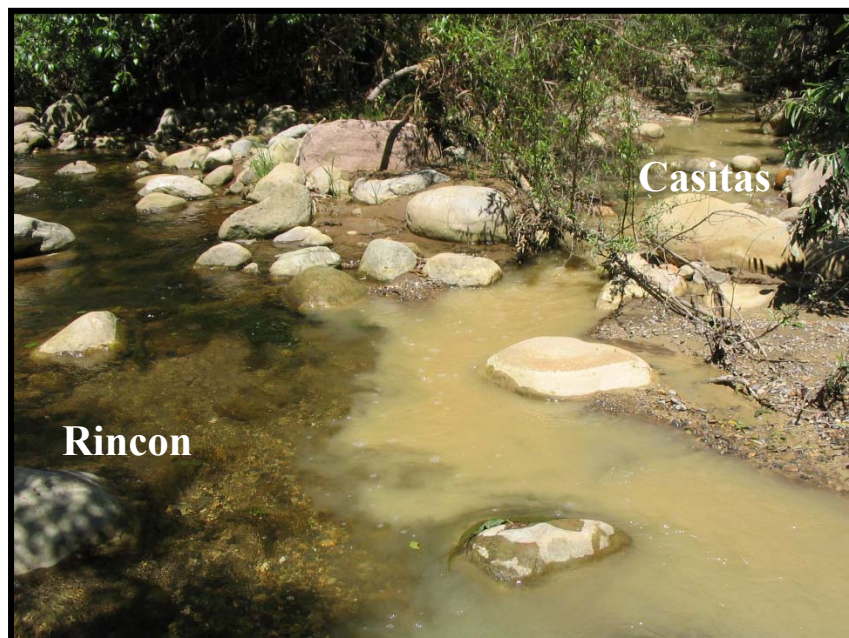
Graphic 7-15: Rincon and Casitas Creeks on Wednesday, May 24, 2006

Two days later, the field crew returned to the confluence. At this time, the water within Rincon Creek was no longer turbid, while Casitas Creek waters remained cloudy, as shown in Graphic 7-15.

Note: Upstream view
